Report ID: 080628-02

145 Main Street
Springfield, Ontario N0L2J0

1748906 Ontario Limited o/a HouseMaster

Inspection Date: 6/28/2008

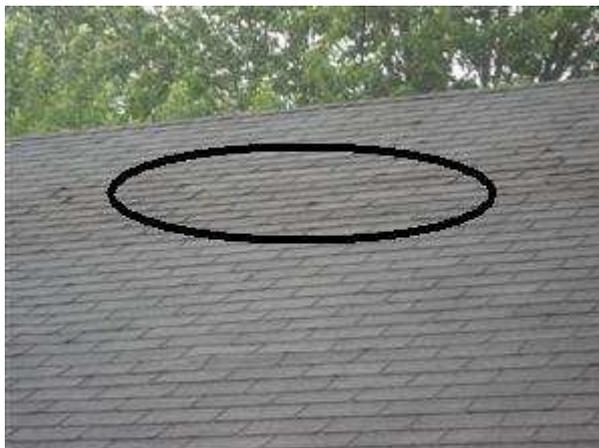
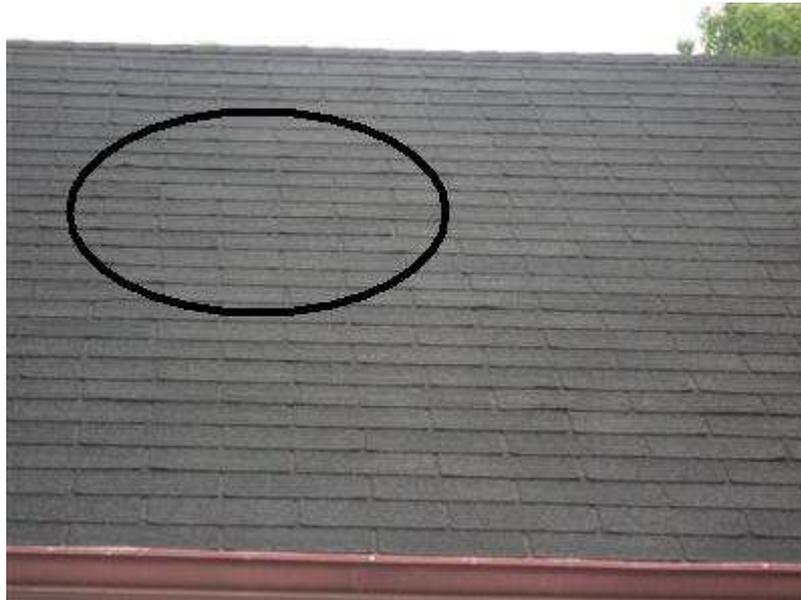
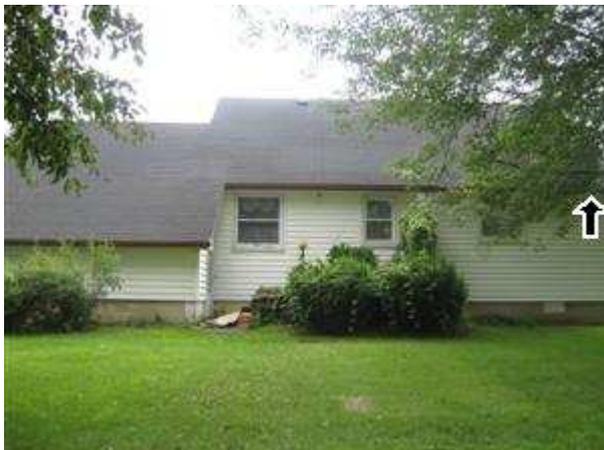
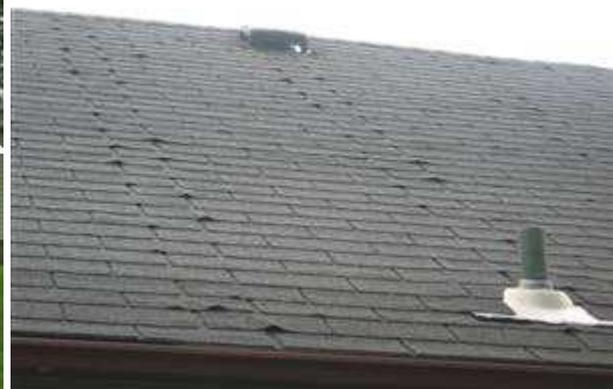
•							1.0 ROOFING Tree limbs in contact with roof. Tree limbs that are in contact with roof or hanging near roof should be trimmed and will require periodic trimming to prevent the abrasive action of branches from rubbing against roofing material and causing premature wear. Shingles are curling in some areas. Curled shingles can be caught and blown off by high winds. Budget for roof replacement in the near future to correct and repair prior to leakage.

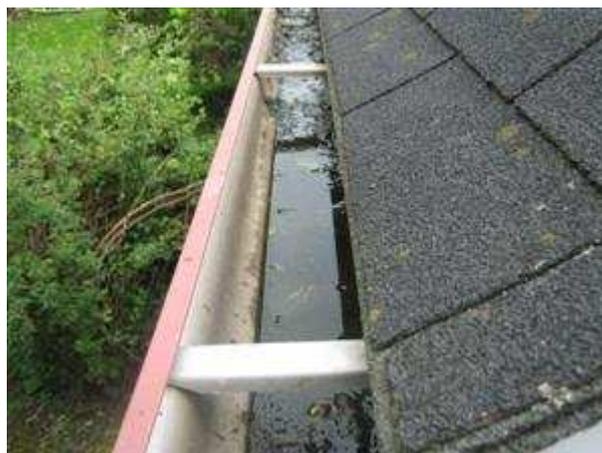
1.5 RAIN GUTTERS / EAVESTROUGHS Picture 1

•										1.1 CHIMNEY / VENTS
•										1.2 EXPOSED FLASHING
•										1.3 VENTILATION COVERS
•										1.4 PLUMBING STACKS
			•							1.5 RAIN GUTTERS / EAVESTROUGHES Gutters are clogged with debris. All gutters should be checked for damage, blockage, or overflow on a regular basis (at least twice annually). Gutter guards may help in cases where leaves and other debris routinely accumulate in a short period of time.

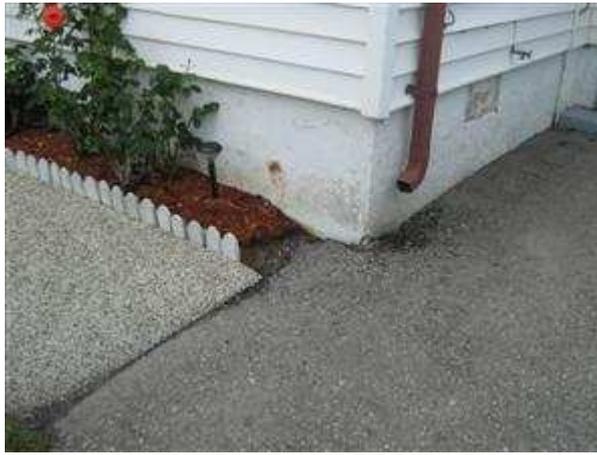
1.6 DOWNSPOUTS / ROOF DRAINS Picture 1

•							1.6 DOWNSPOUTS / ROOF DRAINS Make sure downspouts terminate at least 6 feet away from the foundation. Maintain a positive ground slope away from the house. This prevents moisture from ponding near the foundation and potential seepage into crawlspace or basement.

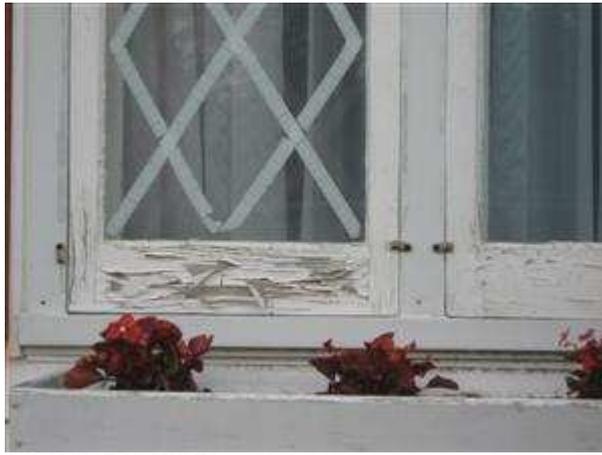
2.1 WINDOWS Picture 1

•					2.0 SIDING
	•				2.1 WINDOWS Old wood frame windows noted. Although windows and frames currently require paint to protect them from the elements, no decayed wood was found with sample probing. Maintenance and painting is required immediately to prevent deterioration of the wood. Some windows have been replaced and updated. Anticipate replacement needs for the remaining original windows.

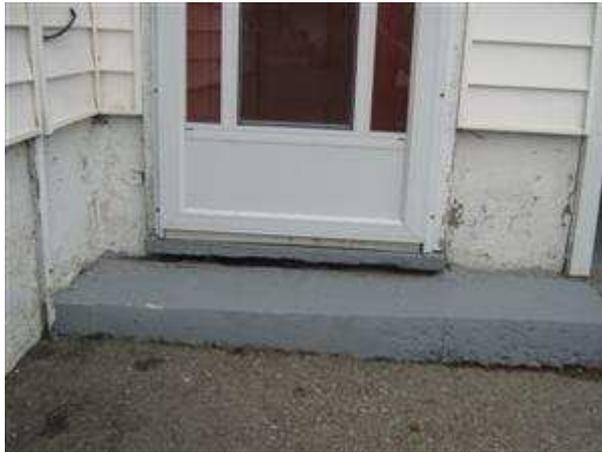
2.2 ENTRY DOORS Picture 1

•			2.2 ENTRY DOORS Exposed wood sills noted. Paint/treat wood to protect wood from elements. Garage entry door is loose at the hinges. Aluminum frame requires tightening and adjustment to prevent from further damage from continued use.

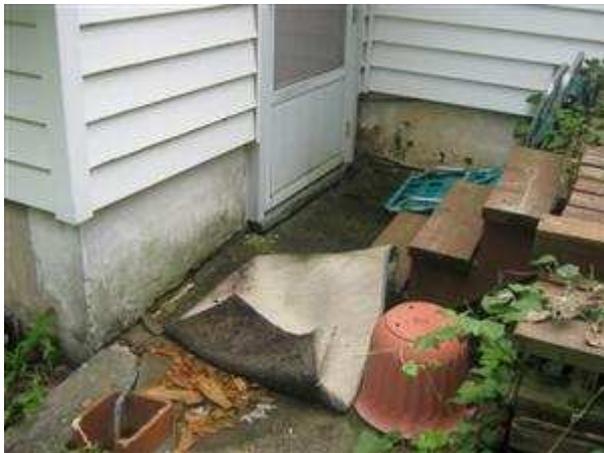
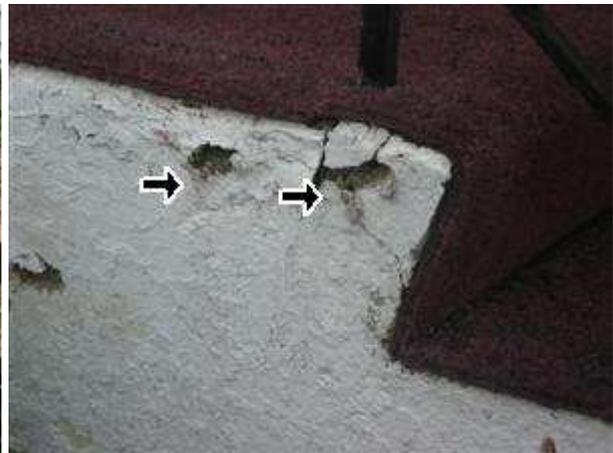
•			2.3 STAIRS / STOOPS Settlement and cracking at the rear entrance. Trip hazards and broken concrete should be removed for safety and repaired to direct water away and to prevent water ponding at the foundation also. Step at the front garage door pitches back towards the foundation directing water and runoff in the wrong direction. Level the step and seal at the foundation to prevent water damage or penetration into crawlspace. Front steps at main entrance are covered in carpet and could not be fully inspected. Some concrete spalling and deterioration has occurred. Patch and repair to prevent further moisture damage.

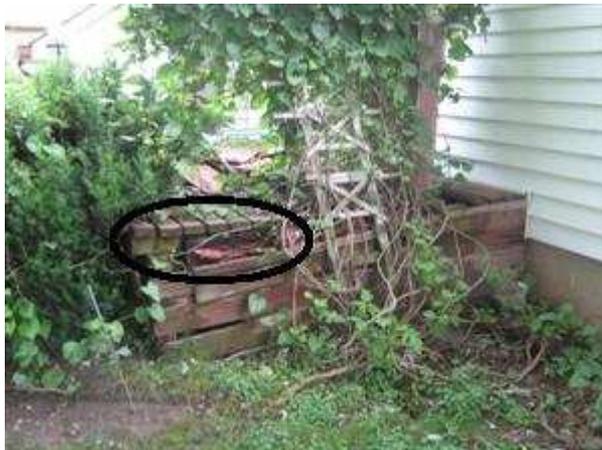
2.4 DECK(S) Picture 1

•			2.4 DECK(S) Deck is damaged and decayed and should not be used. Requires replacement of structure and decking to proper design standards by a qualified contractor.

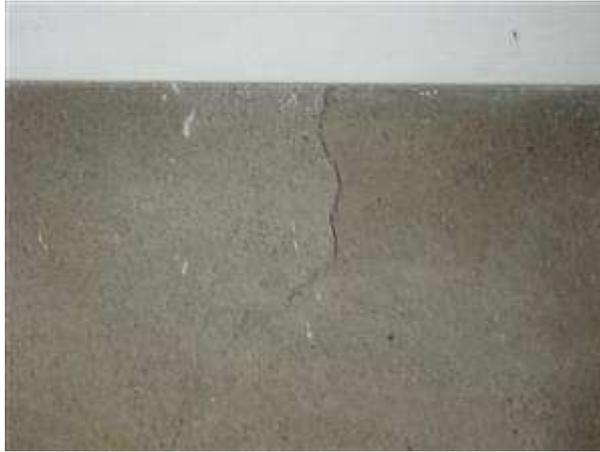
2.6 FOUNDATION SURFACE Picture 1

•					2.5 RAILINGS
	•				2.6 FOUNDATION SURFACE Parge coating noted with some cracking. Parge coating is cosmetic and can be repaired as desired. Use of a parging material restricts the visibility of the foundation and any comments related to the foundation are limited to the visible sections only.
