Client "Confidential Drilling Ltd." Month, Year.
Facility "No-name" drilling package working off Malaysia for "OilCo."
Location Just outside of eating mess.
Equipment DISTRIBUTION PANEL 3.
Component C/B 7 TOP TERMINATION.
Item Report Page. Survey by Anthony Clouder, Tel:+6013-8330093. 14/03/01-10:22 IRP 12.

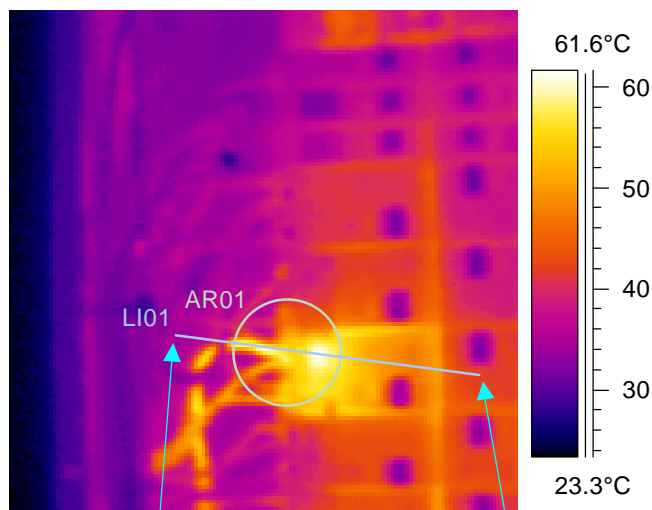
Label	Value
AR01 : max	61.5°C

REMARKS: -
SERIOUS.
27C overheated.
Ultrasound: No additional faults detected.

FAULTY TERMINATION AT C/B 7 TOP.

This is due to one of the wires under the same single screw being loose.
The heat generated or sparking may soon cause C/B damage and /or tripping.
The current and C/B are within correct specifications. Suggest Re-termination.
