**Flooding problem at Ruth Holmes' residence**  
**2259 N. Higley Road**  
**Adjacent to AWCC 16<sup>th</sup> Hole**

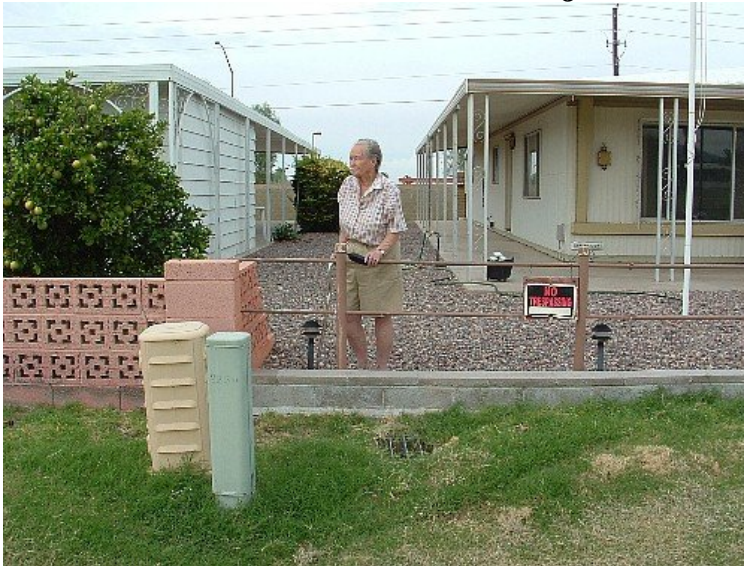
Ruth Holmes surveys the area behind her home on the 16<sup>th</sup> hole, which is subject to constant flooding during heavy rainstorms.

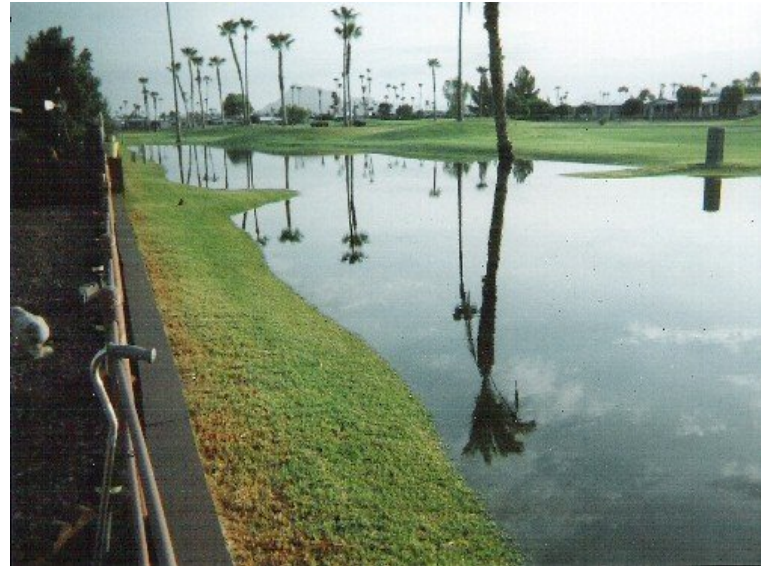
Flooding occurs during heavy rainstorms, saturating the ground and then disappears only through evaporation days later.

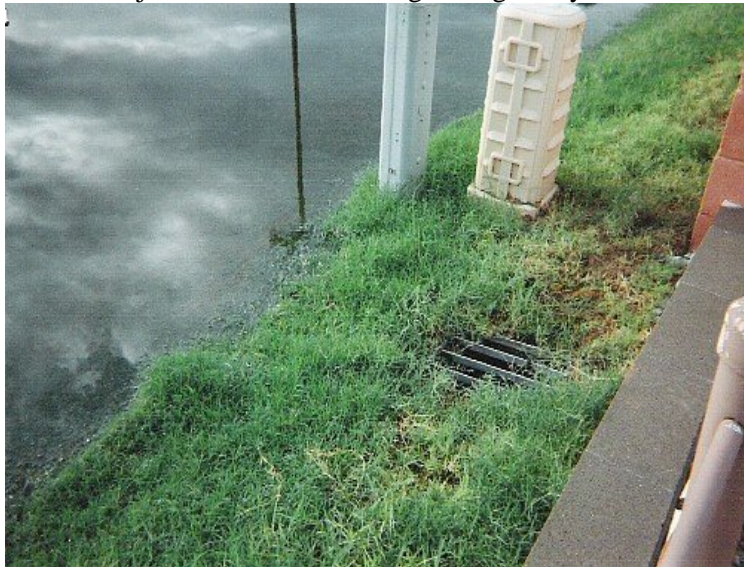
As seen in this photo the floodwater is unable to drain since the drain inlet is well above the level the water.

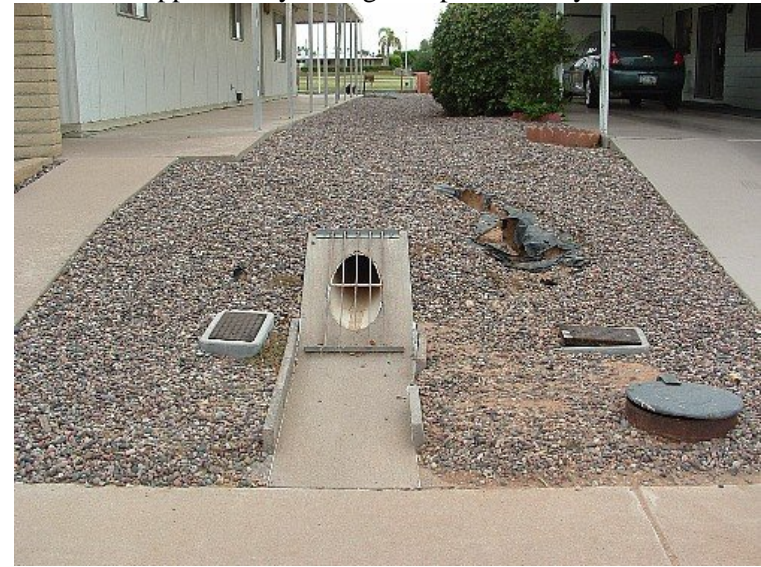
The drain outlet empties onto N. Higley Road, but does not serve its purpose since the floodwaters never reaches the drain inlet.

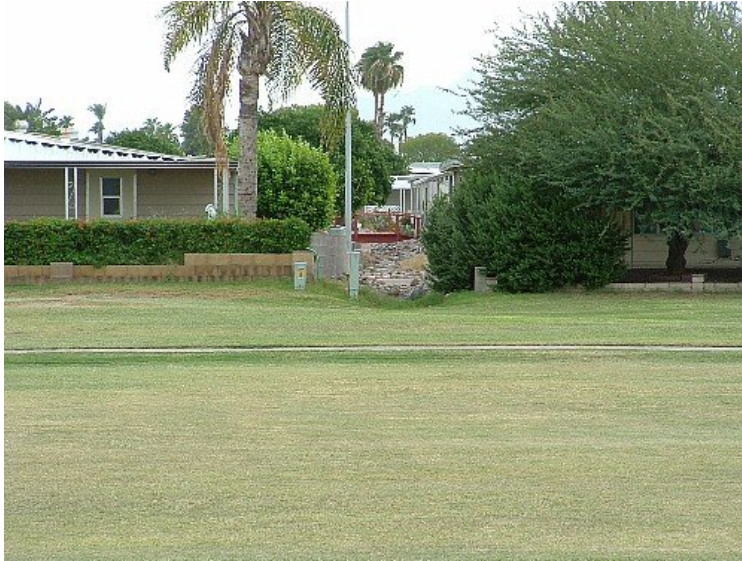
Run off from Nicklaus, Demaret and Floyd runs through this drainage ditch, across the 16<sup>th</sup> fairway and then collects.

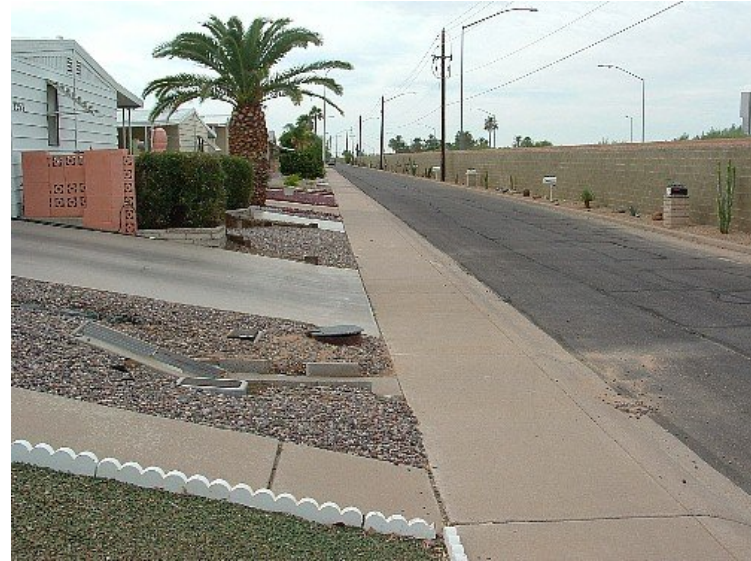
During a heavy rain, water collects on N. Higley and floods the roadway, preventing some residents from getting their mail.

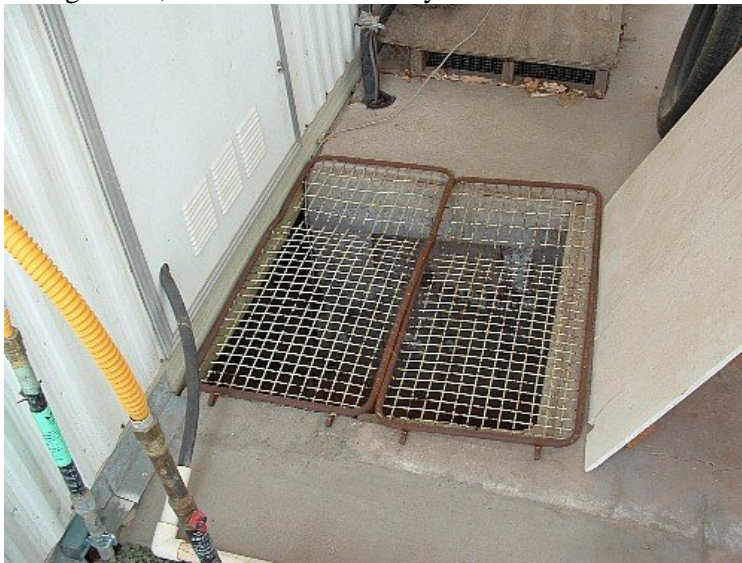
Floodwater that collects and saturates the ground finds its way into the crawl space and takes many days to disappear.

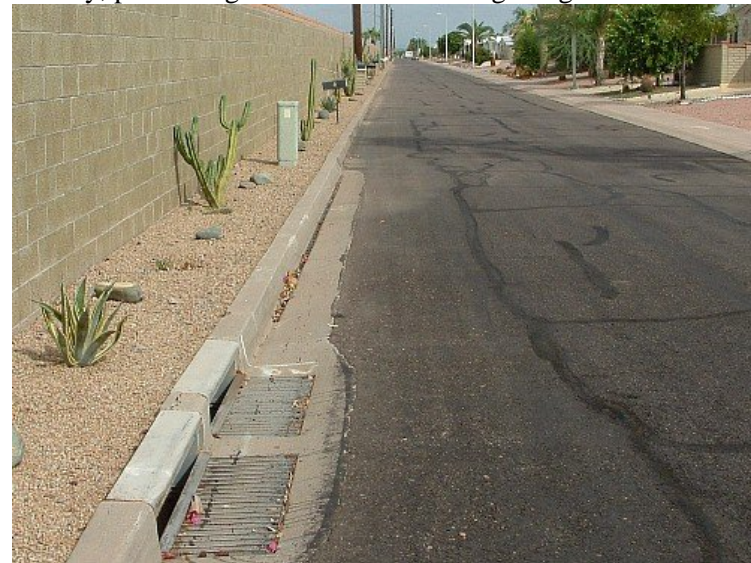
The storm drain located near the entrance to Rosburg Drive is a long way from the homeowners living in the distance.
