VINTAGE AUDIO
RESTORATIONS & ANALYSIS
(303)-444-4210
(EMAIL) SCHUMNOAH@GMAIL.COM

KJ Bleus' Marantz 2325 Receiver

Marantz 2325 Receiver w/ BA312 Upgrade Modules

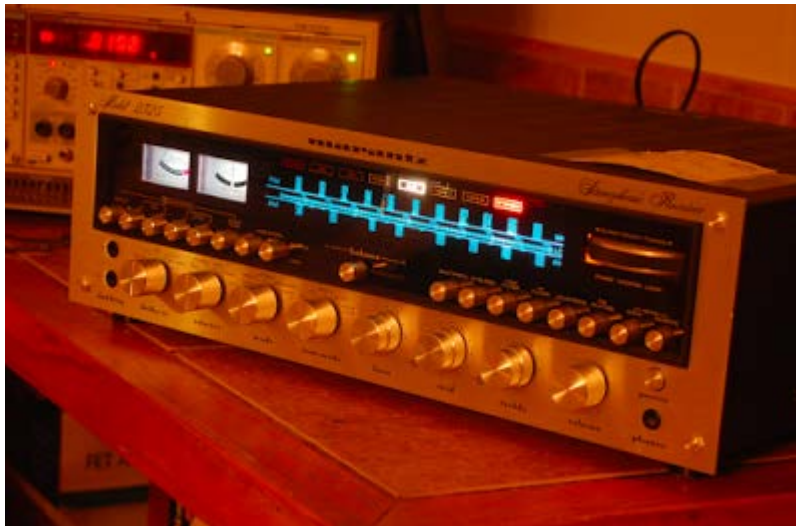
The Marantz 2325 is one of the most popular Marantz receivers, and has remained so for decades. This longevity was achieved thru its superior build quality, pre-amp stage and reliable nature. I often recommend the 2325 and 2275 series as they feature a similar and unique quality in the latter 22/23XX series. This particular 2325 in for restoration also received our proprietary BA312 upgrade in the PE01 pre-amp stage!

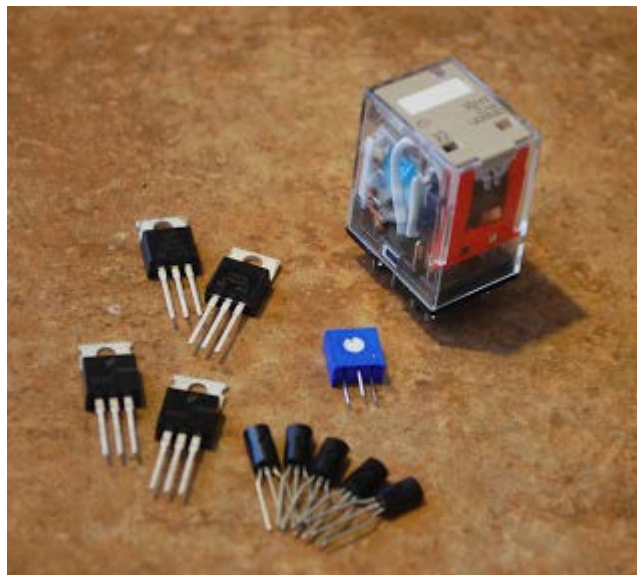
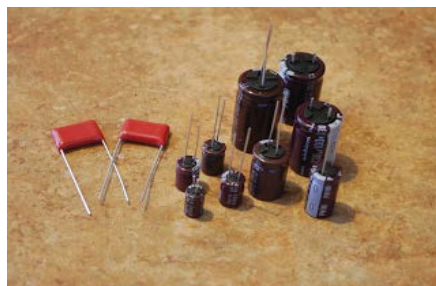
BEFORE

All of the electrolytic capacitors were replaced with a high temp (105C) low impedance Nichicon PW with an increase in operating voltages, the initial decoupling and remaining application capacitors were increased to 1000, 330 and 22MFD capacitors for better dc filtering. Common cathode diodes were replaced with Ultra-Fast, Soft Recovery MUR type TO-220 devices, bypass films were upgrade to a ECW type polypropylene Panasonic.

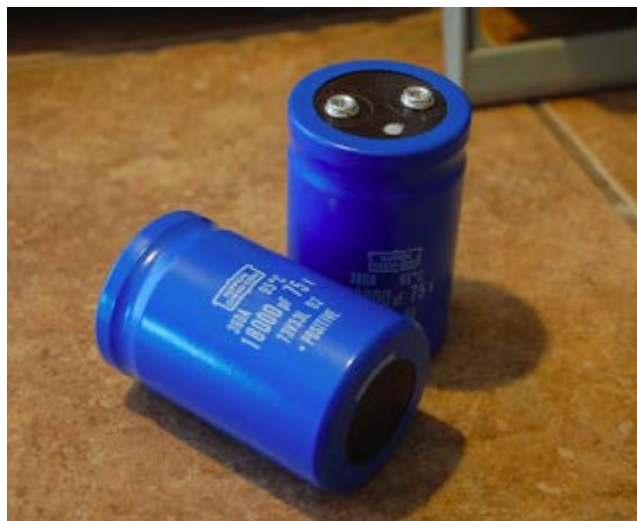
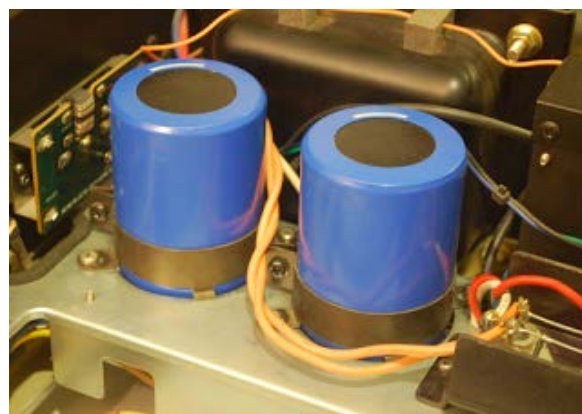
Both 15,000MFD filter capacitors were increased to 18,000MFD computer-grade Nippon Chem-Con capacitors for better filtering/PS reserve.

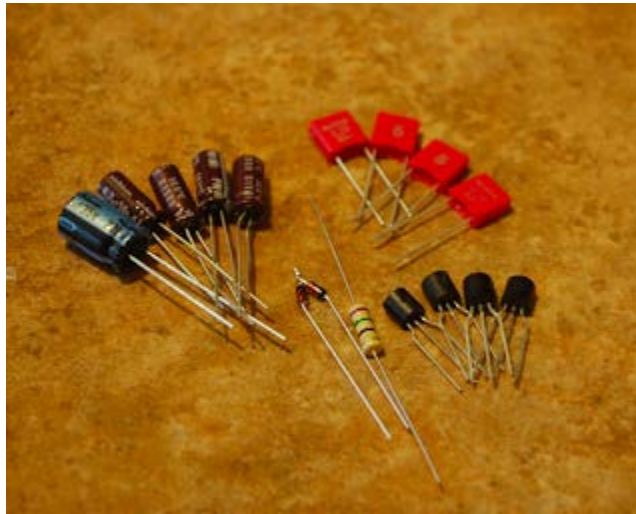
BEFORE

The electrolytic on this assembly were replaced with low impedance Nichicon PW and audio-grade KT capacitors with an increase in operating voltages. The films in this stage were updated to a high-grade WIMA polypropylene film capacitors. The varistor was updated to modern 4148 type diodes in series and all remaining small-signal devices were updated to low noise Fairchild TO-92 and TO-92L type devices. A resistor was replaced as well, as some technician prior has simply put two in series for the correct value...lazy

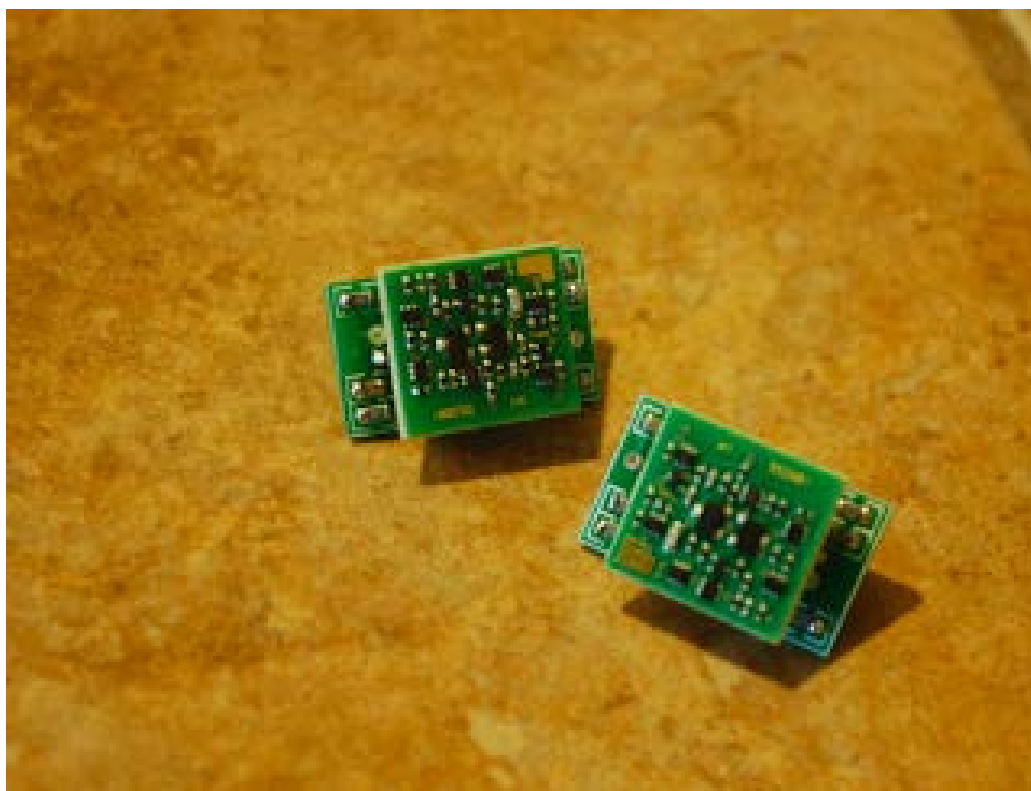
PE01 W/ BA312 AE UPGRADE

The original BA312 integrated-circuit (IC) is a old, early pre-amplifier IC device used as a gain stage in many of the PE01 pre-amp designs including Sansui variants. With great advances in today's high-end operational-amplifier (OP-Amps) we were able to design a circuit that allows for integration of a op-amp into the original BA312 location with no cutting or hacking...and no messy/noisy extra PS rails.

All of the electrolytic capacitors here were replaced with a audio-grade Nichicon KT/KA type, the decoupling capacitor was increased to a 470MFD low impedance PW for better dc filtering, all with an increase in operating voltages. The output bipolar were replaced with a audio-grade Nichicon MUSE BiPolar type. Input and all coupling films including electrolytic at 1<MFD were all replaced with a high-grade WIMA polypropylene type film capacitors. Lastly the original BA312 IC's were both removed and replaced per instructions with the Analog Esoteric BA312 Upgrade Module pairs.

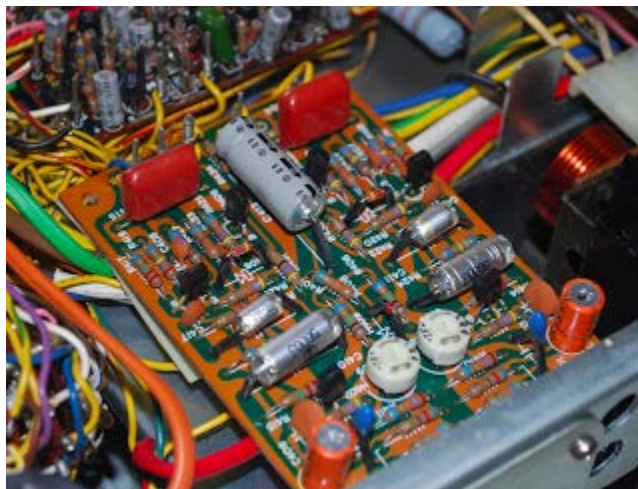
BEFORE

Like the PE01 pre-amp stage the P400 phono stage is another very popular design used in many of the 22/23XX series receiver. The P400, with our proper upgrades has a very linear and accurate RIAA Curve response.

The decoupling 220MFD filter capacitor was increase to a 330MFD in a more reliable radial package designed, low impedance Nichicon PW, remaining electrolytic were replaced with a audio-grade Nichicon KT all with an increase in operating voltages. The original tantalum was replaced, along with the inputs to high-grade WIMA polypropylene films. The varistor and associated diodes were replaced with modern fairchild 4148 type, the failure prone 2SC458 and remaining small signal devices were replaced with low noise Fairchild TO-92 devices. Both clipping adjustments were replaced to precision Bourns potentiometers.

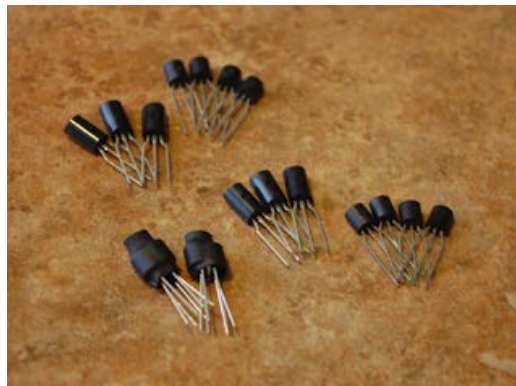
Beta Mapping

The differential pairs were matched with 2% and thermally coupled together with beta mapping notated below for confirmation. Remaining devices to pre-driver were updated with modern Fairchild TO-92 and TO-92L type devices. As I've mentioned these type of pots before on Marantz I recommend cleaning them versus replacement and ensure tracking. The diode service bulletin addressed as well.

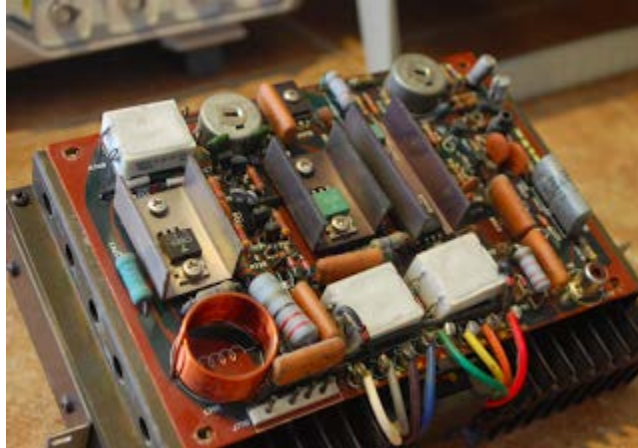
BEFORE

The 2325 uses a differential gain stage and current stage which drives the eventual pre-drivers, the drivers are tied to the dynamic bias circuit.

The electrolytic capacitors were replaced with a audio-grade Nichicon KT including replacing the 33MFD tantalum to KT, all with an increase in operating voltages. All of the input and bypass films were upgraded to a high-grade WIMA polypropylene type film capacitors.

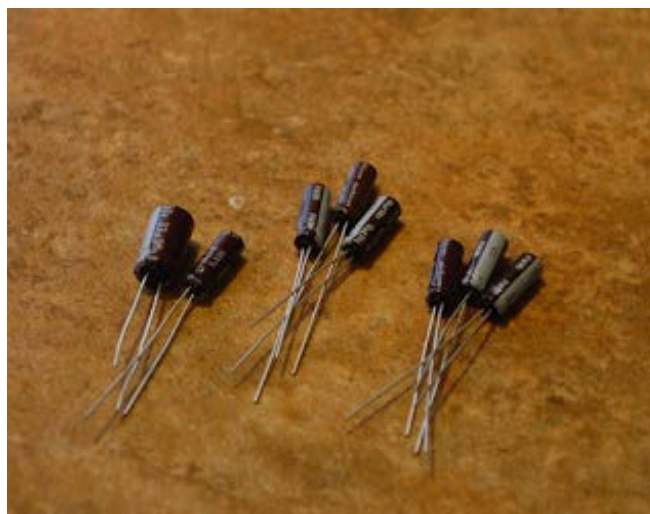
BEFORE

Remaining key RF stages including Dolby Noise Reduction had their respective electrolytic capacitors replaced with low impedance, high temp (105C) Nichicon PW and Panasonic FC capacitors with an increase in operating voltages.

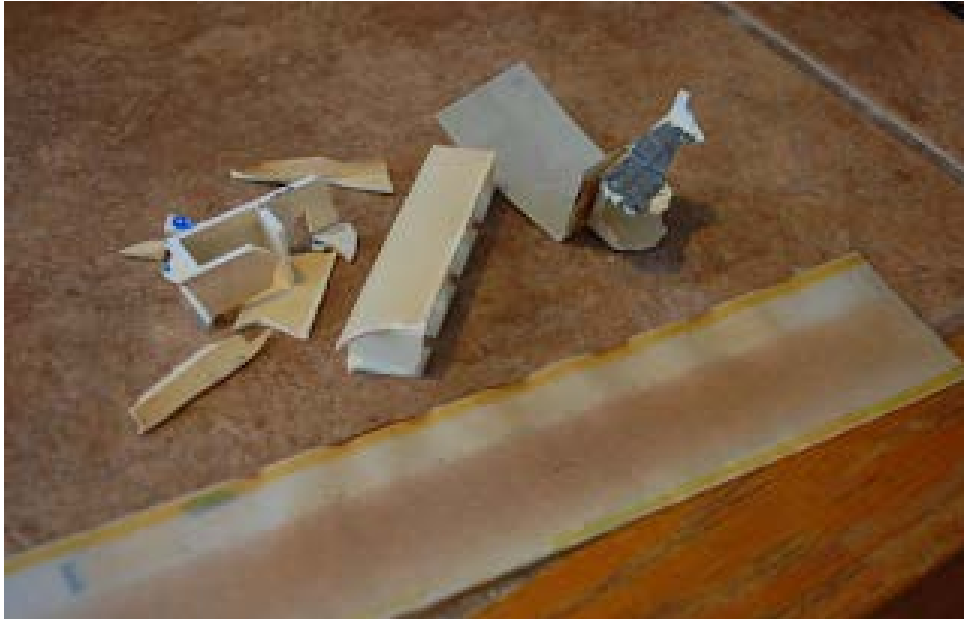
Lamps & LEDs

Like most units, this customer left us a surprise of a totally destroyed lamp housing. As we've mentioned dozens of times, you **CANNOT** use old incandescent type lamps in these vintage units. It utterly melts and destroys the plastic shroud. In this case a old-stock replacement shroud was installed and the original broken plastic removed. New Vellum paper and New Meter Vellum paper was installed.

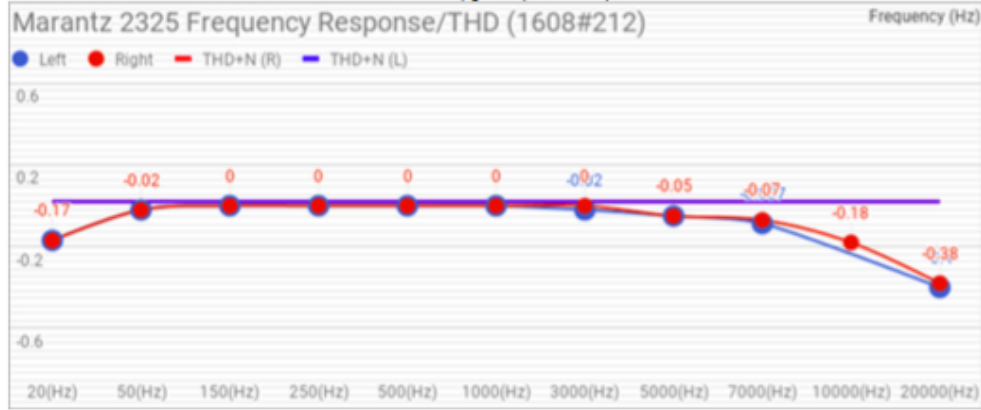
DATASET : Frequency Response 20Hz-20Khz -0.4/0+dB

LOAD FACTOR: LEFT 8OHM LOAD @ 1W

RIGHT 8OHM LOAD @ 1W

INPUT FACTOR: SINE @ .003%dB THD+N

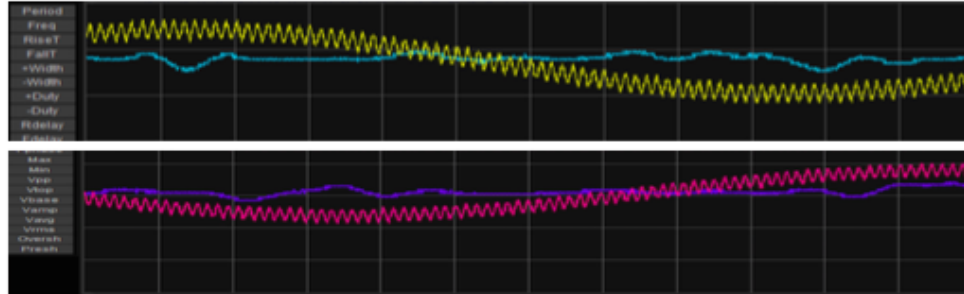
DATASET FIG4: Intermodulation Distortion (IMD)(L)

DATASET FIG4: Intermodulation Distortion (IMD)(R)

INPUT FACTOR: 60Hz + 7Khz 4:1 (8OHM/L)

INPUT FACTOR: 60Hz + 7Khz 4:1 (8OHM/R)

(IMD): 8OHM/L 3.05Vrms 0.0230%

(IMD): 8OHM/R 3.02Vrms 0.0236%

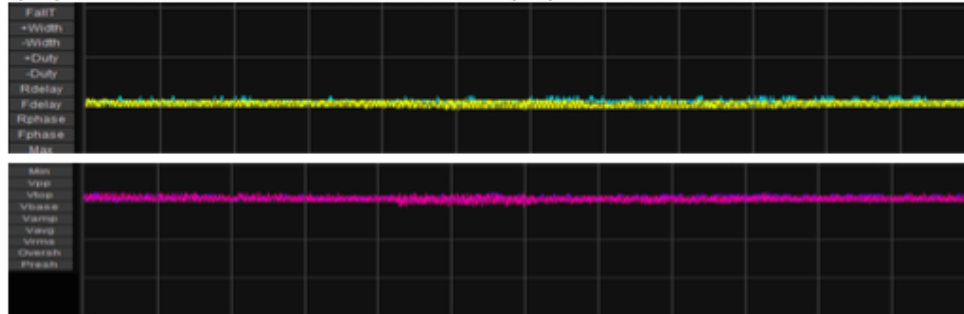
S/N Ratio (S/N) 8OHM/L: LINE/OUT -98.7dB

S/N Ratio (S/N) 8OHM/R: LINE/OUT -98.4dB

Separation (L/R dB): dB (31/0.019) -64.25dB

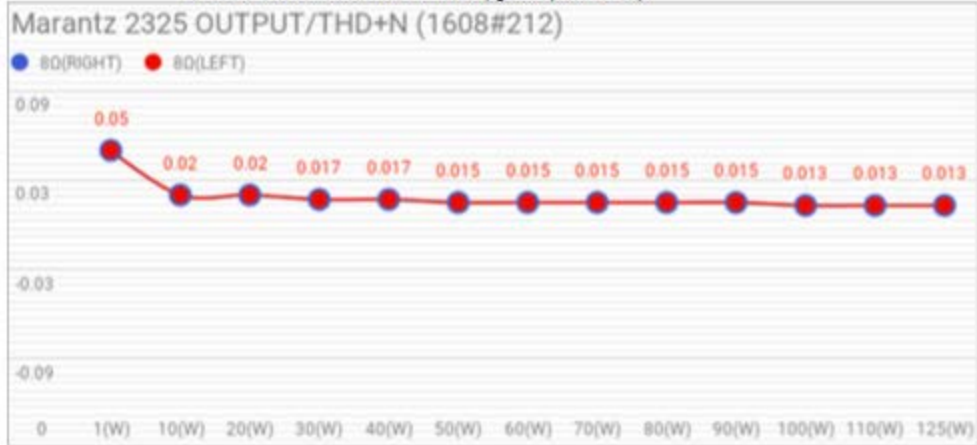
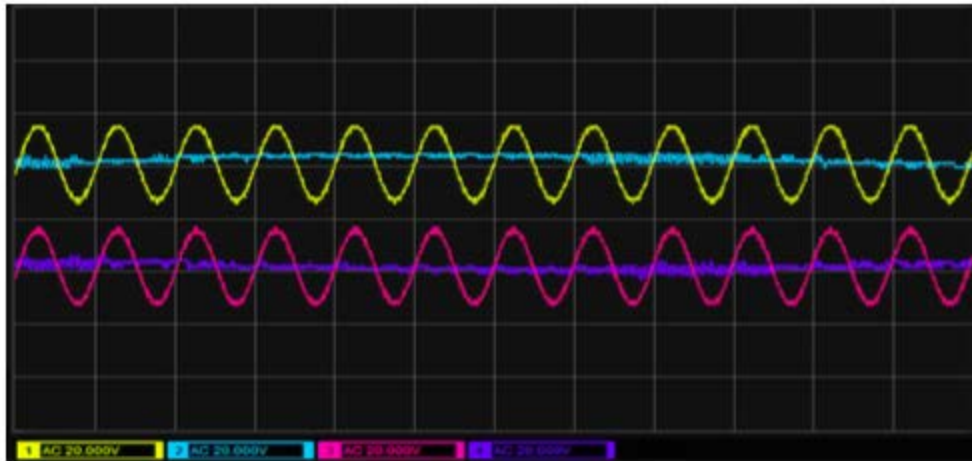
LOAD FACTOR: @Rated - 80HM/L LOAD
 INPUT FACTOR: SINE @ .003%dB THD+N
 LEFT 125.61W/CH (31.7Vrms) @ 0.013% dB THD+N

LOAD FACTOR: @Rated - 80HM/R LOAD
 INPUT FACTOR: SINE @ .003%dB THD+N
 RIGHT 125.61W/CH (31.7Vrms) @ 0.013% dB THD+N

AV Gain: +29.82dB
