Client "Confidential Drilling Ltd." Month, Year.
Facility "No-name" drilling package working off Malaysia for "OilCo."
Location Just outside of eating mess.
Equipment DISTRIBUTION PANEL 3.
Component C/B 7 TOP TERMINATION.
Item Report Page. Survey by Anthony Clouder, Tel:+6013-8330093. 14/03/01-10:22 IRP 12.

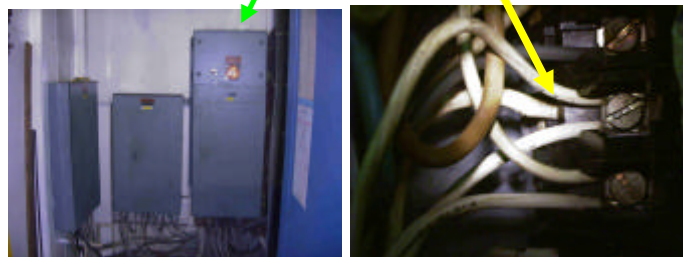
REMARKS: -
SERIOUS.
27C overheated.
Ultrasound: No additional faults detected.

FAULTY TERMINATION AT C/B 7 TOP.

This is due to one of the wires under the same single screw being loose.
The heat generated or sparking may soon cause C/B damage and /or tripping.
The current and C/B are within correct specifications. Suggest Re-termination.

A screw may not tighten down on one wire as much as on another. This could cause the looser of the wires to give problems. Give a twist to the stripped wire strands on each wire, then "Tin" them. (i.e. Run solder into each.) Solder being soft, will flatten-out a little, giving a better contacting surface thereby averting this problem.
