Ohio Department of Natural Resources Division of Water Fact Sheet

Fact Sheet 99-51

Dam Safety: Outlet Erosion Control Structures (Stilling Basins)

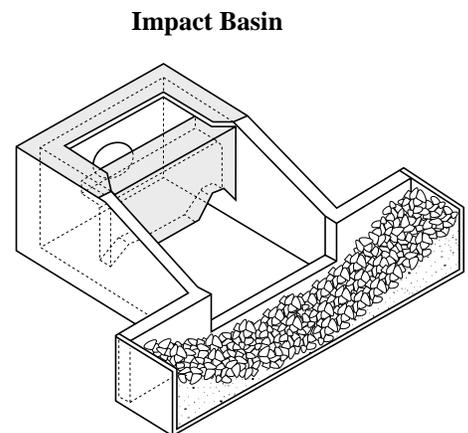
A concrete impact basin is an energy dissipating device located at the outlet of the spillway in which flow from the discharge conduit strikes a vertical hanging baffle. Discharge is directed upstream in vertical eddies by the horizontal portion of the baffle

and by the floor before flowing over the endsill. Energy dissipation occurs as the discharge strikes the baffle, thus, performance is not dependent on tailwater. Most impact basins were de-

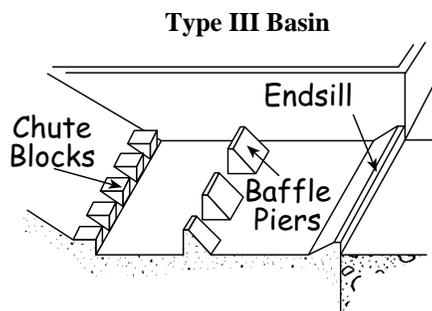
U.S. Department of Interior, Bureau of Reclamation Type II and Type III Basins

Type II and Type III basins reduce the energy of the flow discharging from the outlet of a spillway and allow the water to exit into the outlet channel at a reduced velocity. Type II energy dissipators contain chute blocks at the upstream end of the basin and a dentated (tooth-like) endsill. Baffle piers are not used in a Type II basin because of the high velocity water entering the basin.

Type III energy dissipators can be used if the entrance velocity of the water is not high. They contain baffle piers which are located on the stilling basin apron downstream of the

chute blocks. Located at the end of both the Type II and Type III basins is an endsill. The endsill may be level or sloped, and its purpose is to create the tailwater which reduces the outflow velocity. If any of the severe defects associated with concrete structures are observed, a registered professional engineer should be contacted to evaluate the stability of the basin.

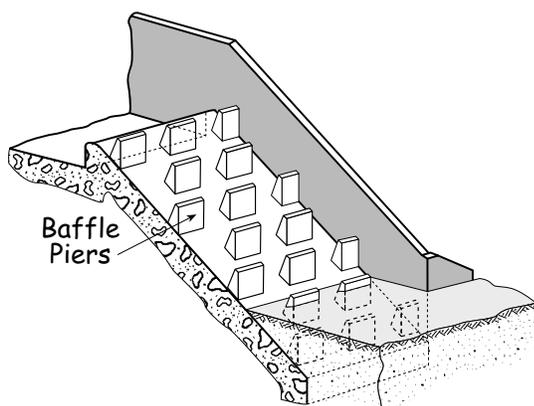
Baffled Chute Basin

Baffled chutes require no initial tailwater to be effective and are located downstream of the control section. Multiple rows of baffle piers on the chute prevent excessive acceleration of the flow and prevent the damage that occurs from a high discharge velocity. A portion of the baffled chute usually extends below the streambed elevation to prevent undermining of the chute. If any of the severe problems associated with concrete that are referenced in the opening paragraphs are observed, a registered professional engineer should be contacted to evaluate the stability of the outlet.

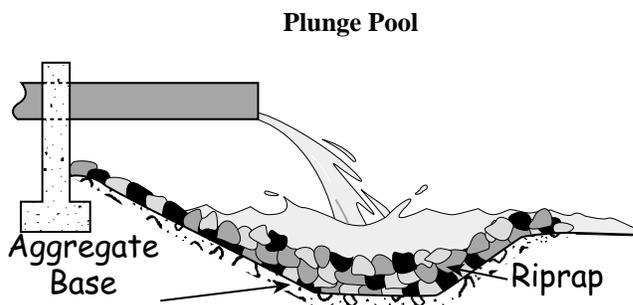
Plunge Pool

A plunge pool is an energy dissipating device located at the outlet of a spillway. Energy is dissipated as the discharge flows into the plunge pool. Plunge pools are commonly lined with rock riprap or other material to prevent excessive erosion of the pool area. Discharge from the plunge pool should be at the natural streambed elevation. Typical problems may include movement of the riprap, loss of fines from the bedding material and

scour beyond the riprap and lining. If scour beneath the outlet conduit develops, the conduit will be left unsupported and separation of the conduit joints and undermining may occur. Separation of the conduit joints and undermining may lead to failure of the spillway and ultimately the dam. A registered professional engineer should be contacted to ensure that the plunge pool is designed properly.
